HOUSE OF FORGINGS LLC TEST REPORT

OSHA 1910.29 TESTING ON STEEL GUARDRAIL

L8190.01-119-19 R0

TEST REPORT FOR HOUSE OF FORGINGS LLC

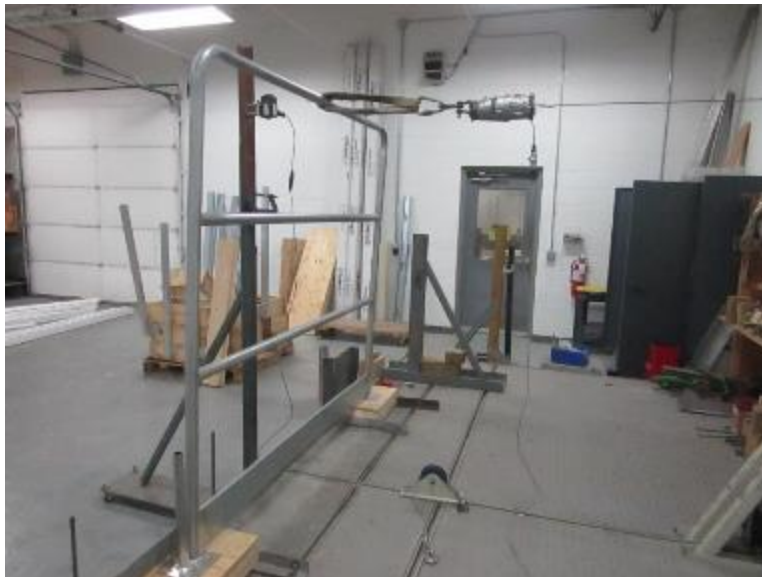
Photo No. 1

Concentrated Horizontal Load at Mid-Span of Top Rail

Design Load: 200 lb Horizontal Concentrated Load at Mid-Span of Top Rail

LOAD LEVEL	TEST LOAD (lb)	E.T. (min:sec)	DISPLACEMENT (in)
200 lb (D.L.)	201	00:48	9.69

Result: Withstood load equal to or greater than 200 lb without failure

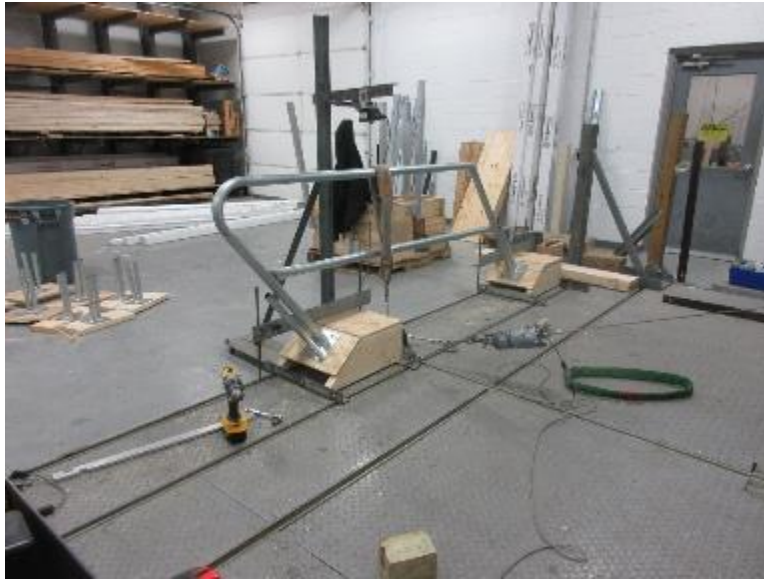
Photo No. 2
Concentrated Vertical Load at Mid-Span of Top Rail

Design Load: 200 lb Vertical Concentrated Load at Mid-Span of Top Rail

LOAD LEVEL	TEST LOAD (lb)	E.T. (min:sec)	DISPLACEMENT (in)
200 lb (D.L.)	202	00:18	0.26

Result: Withstood load equal to or greater than 200 lb without failure

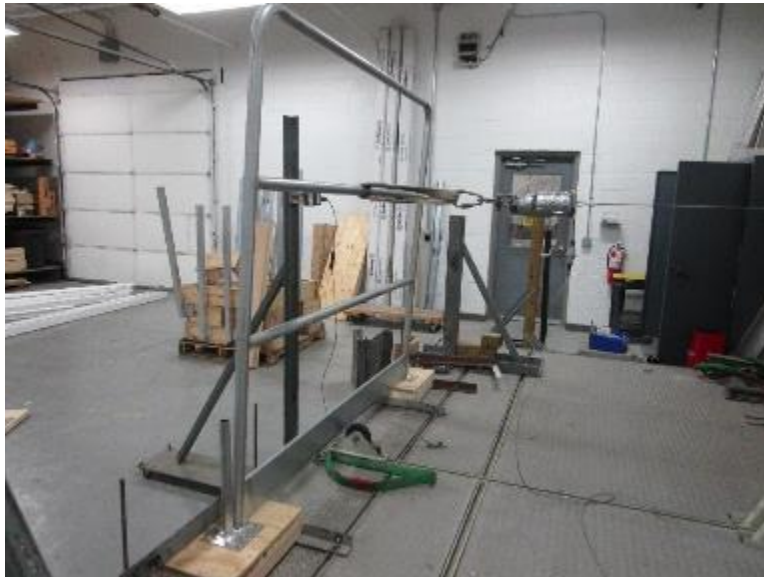
Photo No. 3
Concentrated Horizontal Load at Mid-Span of Mid Rail

Design Load: 150 lb Horizontal Concentrated Load at Mid-Span of Mid Rail

LOAD LEVEL	TEST LOAD (lb)	E.T. (min:sec)	DISPLACEMENT (in)
150 lb (D.L.)	154	00:32	2.66

Result: Withstood load equal to or greater than 150 lb without failure

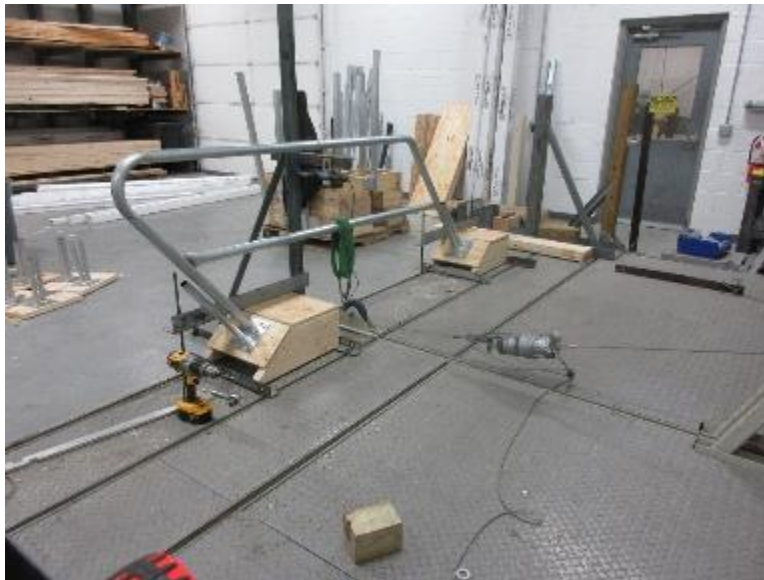
Photo No. 4
Concentrated Vertical Load at Mid-Span of Mid Rail

Design Load: 150 lb Vertical Concentrated Load at Mid-Span of Mid Rail

LOAD LEVEL	TEST LOAD (lb)	E.T. (min:sec)	DISPLACEMENT (in)
150 lb (D.L.)	152	00:21	0.12

Result: Withstood load equal to or greater than 150 lb without failure

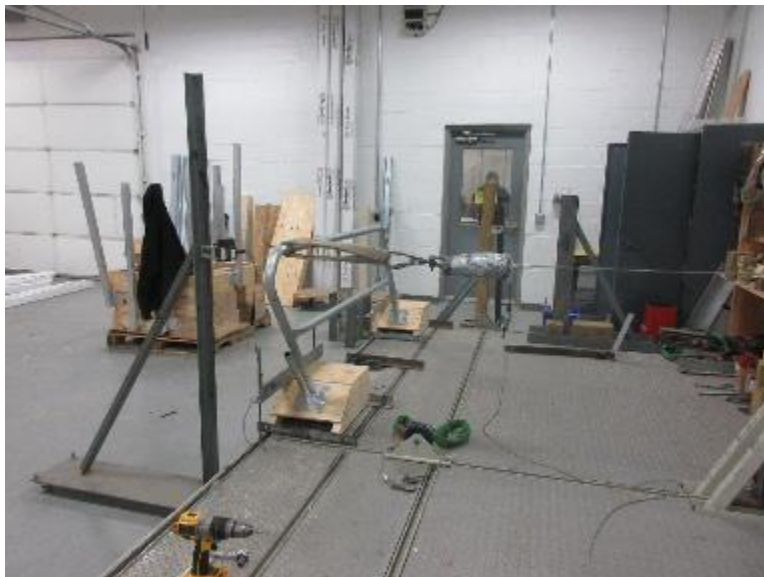
Photo No. 5
Concentrated Horizontal Load at End of Top Rail

Design Load: 200 lb Horizontal Concentrated Load at End of Top Rail

LOAD LEVEL	TEST LOAD (lb)	E.T. (min:sec)	DISPLACEMENT (in)
200 lb (D.L.)	201	00:58	9.31

Result: Withstood load equal to or greater than 200 lb without failure

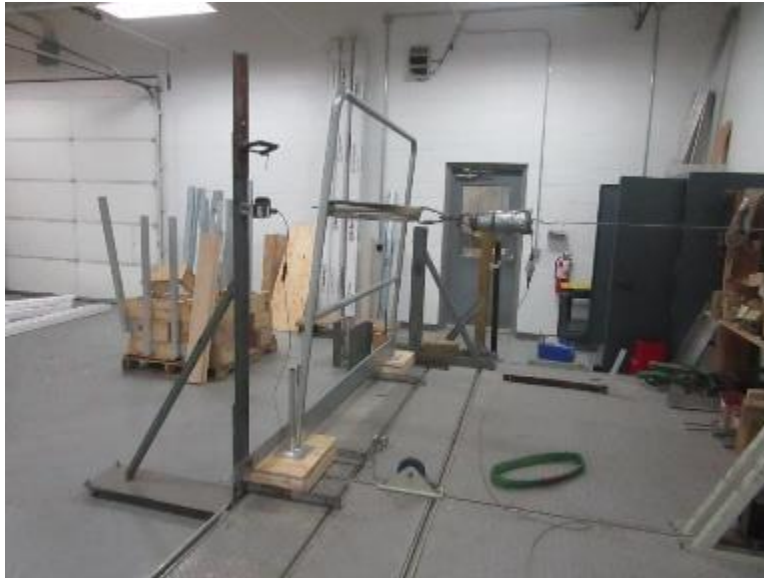
Photo No. 6
Concentrated Horizontal Load at End of Mid Rail

Design Load: 150 lb Horizontal Concentrated Load at End of Mid Rail

LOAD LEVEL	TEST LOAD (lb)	E.T. (min:sec)	DISPLACEMENT (in)
150 lb (D.L.)	153	00:32	2.76

Result: Withstood load equal to or greater than 150 lb without failure

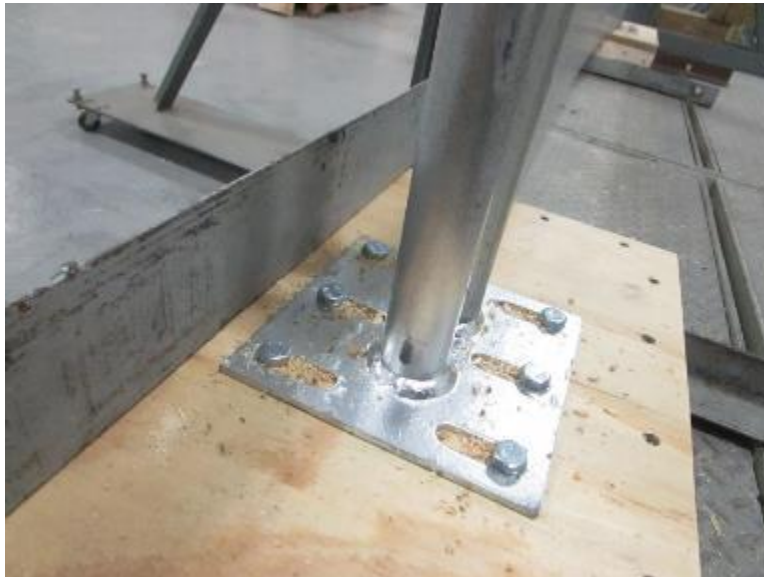
Photo No. 7
Level Post Base Connection to 3/4 in Plywood Over Flat 2X SPF Lumber

WOOD FLOOR MOCKUP CONSTRUCTION	2X SPF joist and headers with 3/4 in thick plywood sheathing and a piece of 2x8 SPF dimensioned lumber blocking laid flatwise directly under the plywood

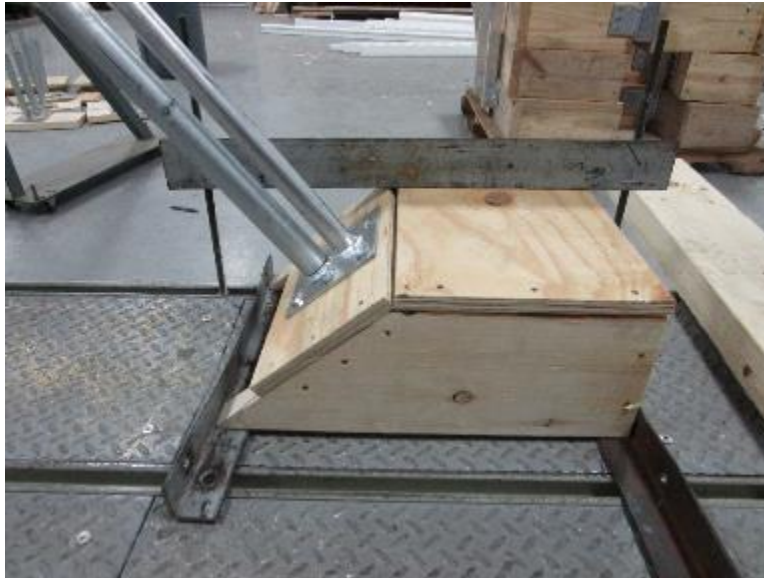
Photo No. 8

Stair Post Base Connection to 3/4 in Plywood Over Flat 2X SPF Lumber

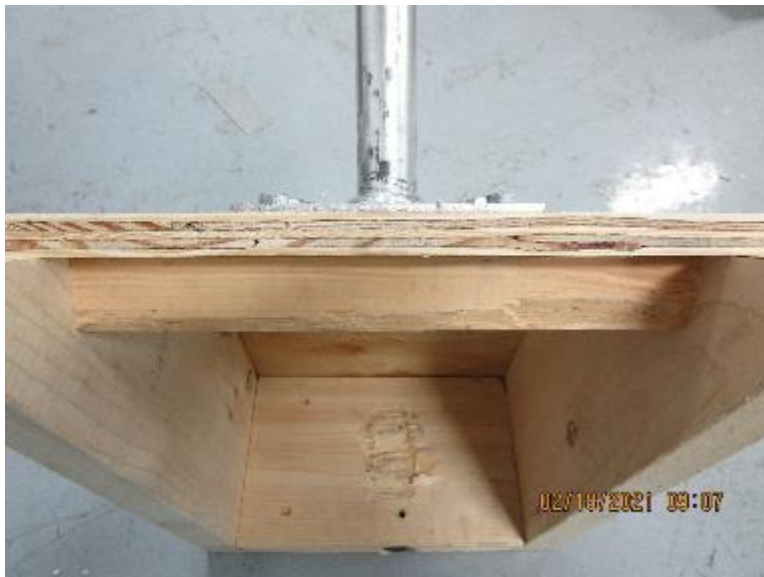
Photo No. 9

3/4 in Plywood Over Flat 2X SPF Lumber

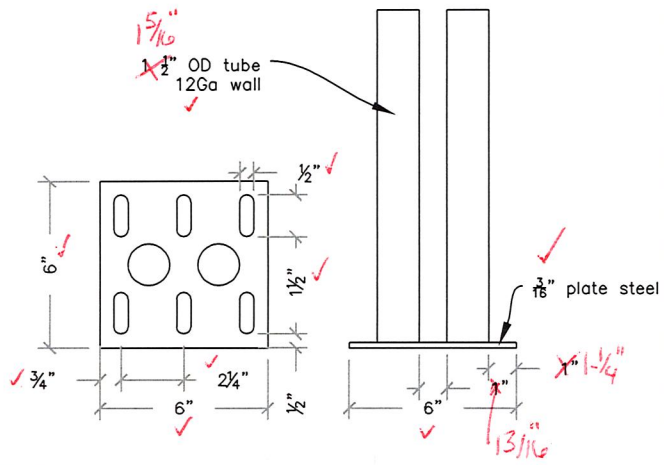
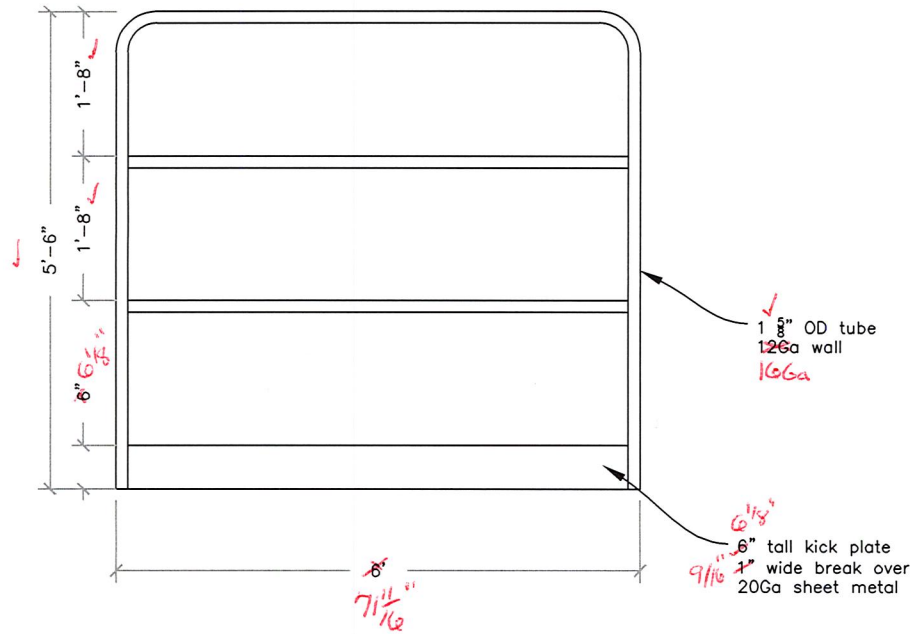
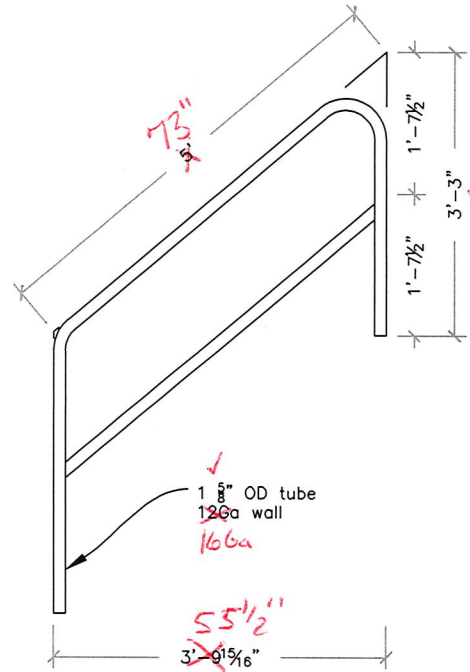
Ironwood Connection
Safety Rail system

The "As-Built" drawings for the level and stair steel guardrail which follow have been reviewed by Intertek B&C and are representative of the project reported herein. Project construction was verified by Intertek B&C per the drawings included in this report. Any deviations are documented herein or on the drawings.

Test sample complies with these details.
Deviations are noted.

The guardrail system is comprised of steel tube rails and posts. Drawings are included in Section 10 to verify the overall dimensions and other pertinent information of the tested product, its components, and any constructed assemblies. Photographs are provided in Section 9.

MATERIAL	Steel
RAIL AND POST	1.660 in outside diameter by 0.068 in thick wall (16 gauge)
RAIL LENGTH	-68-3/8 in (inside of post to inside of post; level) -69 in (inside of post to inside of post measured parallel to the rail; stair)
RAIL HEIGHT	-66 in (top of top rail to bottom of post/kick plate; level) -39 in (top of top rail to bottom of post measured parallel to the post; stair)
POST BASE	Two, 1.315 in outside diameter by 16 in long by 0.110 in thick wall (12 gauge) tubes attached to 6 in square 3/16 in thick steel plate with 1/4 in fillet welds all around. The base plate included six 1/2 in diameter by 1-1/2 in long slotted holes
KICK PLATE	6-1/8 in high by 9/16 in deep by 0.100 in thick (12 gauge) C-shaped member (level rail only)
CONNECTIONS	- Intermediate Rail to Post: 3/16 in fillet weld all around - Kick Plat to Post: Three 1 in long by 3/16 in fillet welds - Post Base to Wood Floor Mockup: Six, 3/8-7 by 1-1/2" hex head lag bolts (three per side) located at end of slot next to edge of plate
